# Safety Alert

## Injury to thumb

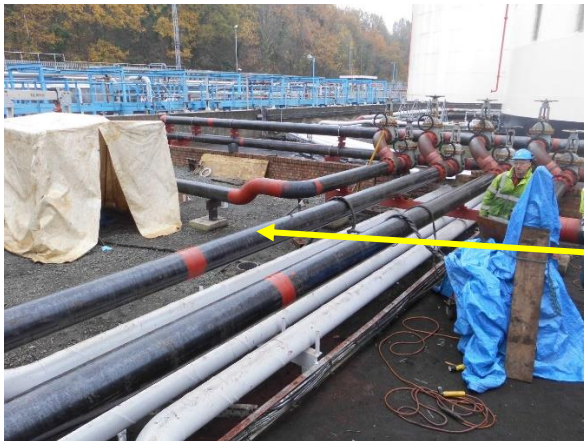
- Contractors were passing pipe supports over these pipes.
- They used the pipe to lean over and pass the support.
- During this task the pipe support slipped and fell onto the contractor's hand trapping it between the support and the pipe, injuring his thumb

Although the lifting of the support on its own was not an issue, stretching to pass it over pipe work should have alerted them to re assess.

Manual handling assessment should of highlight a safer way to get supports across which would of avoiding stretching to pass supports over.
